**Interim Report
on the
Crash of TWA Flight 800
and the
Actions of the NTSB and the FBI**

Cmdr. William S. Donaldson, USN Ret.

July 17, 1998

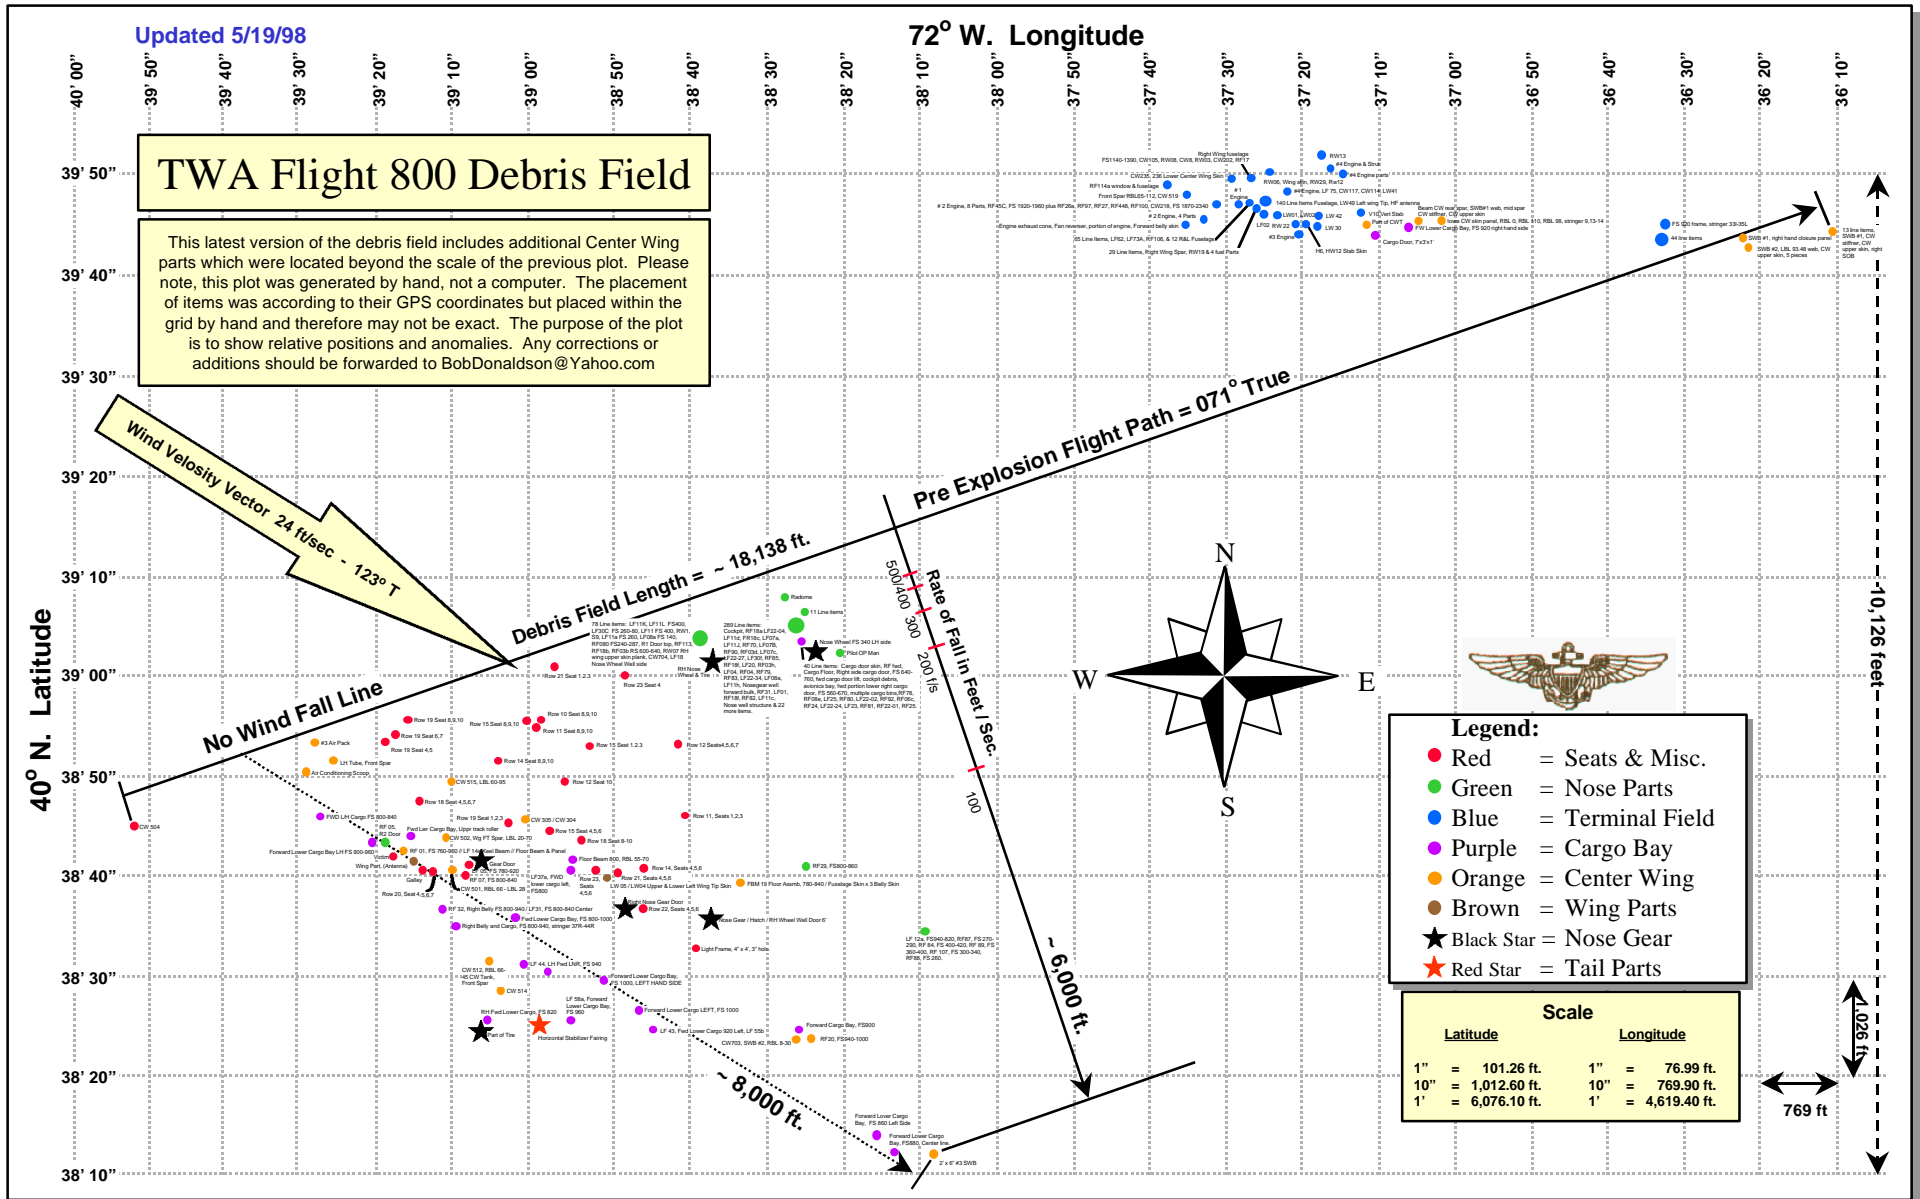
Exhibit 5 - TWA Flight 800 Debris Field

Fact: The majority of the actual center wing tank parts, that you would expect to be ejected in a tank explosion, were found 4,000 feet farther east than any other significant aircraft structure.

Comment: It appears the Debris Field database was not released to the public because the NTSB could not explain the wide separation of debris (18,000' long and 8,000' wide) and the amount of damage to the aircraft that is indicated by the distribution of debris. See Exhibit 5 on page 44.

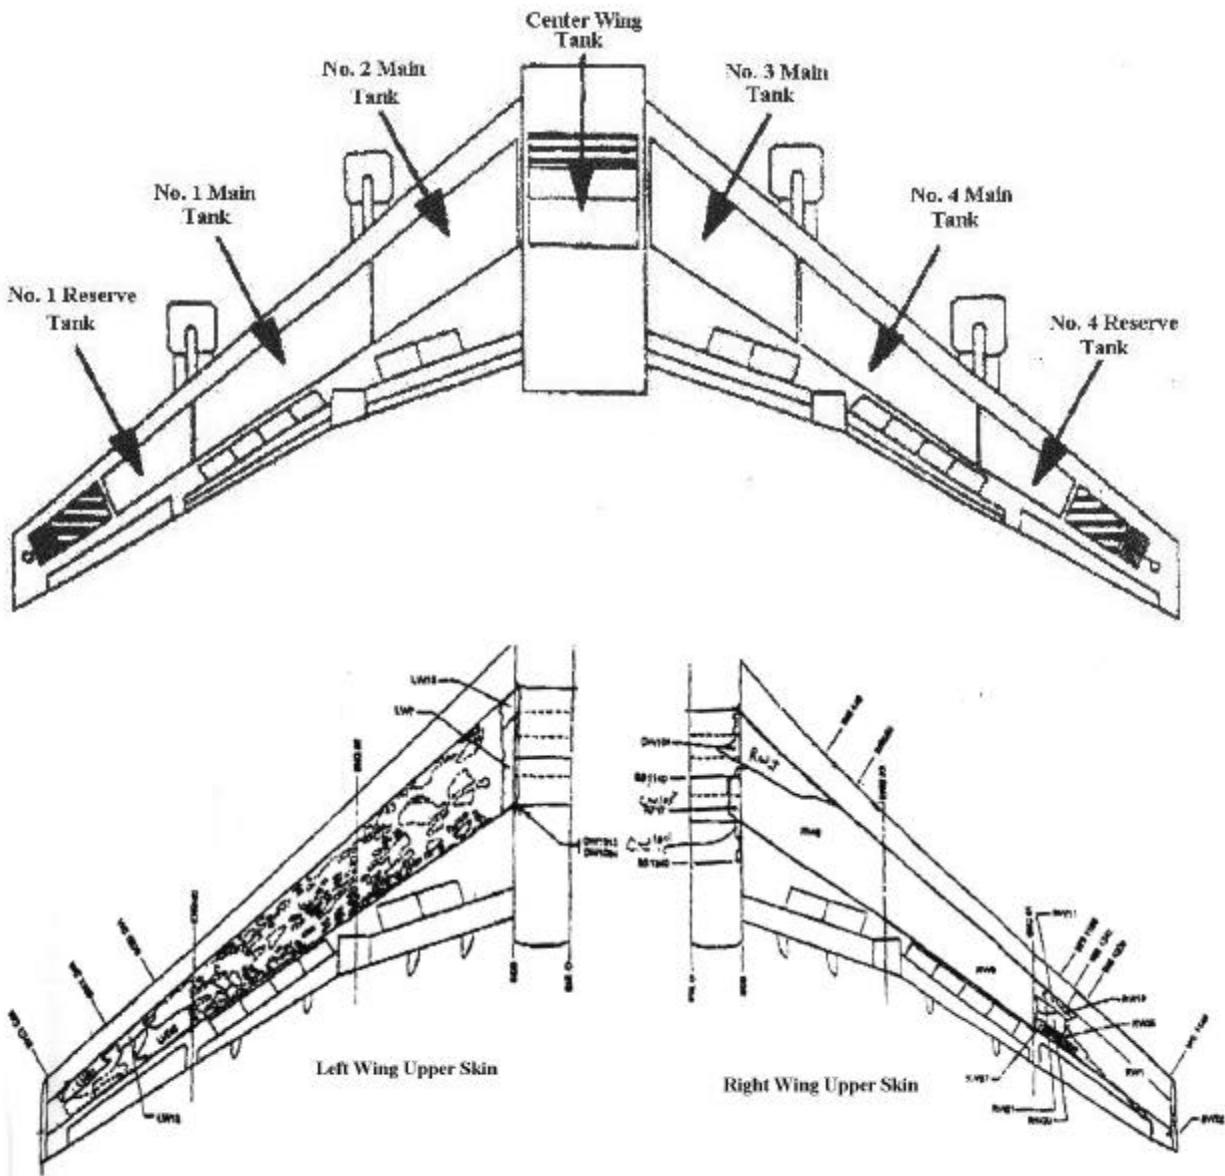
The first diagram shows a normal 747 wing with the location of the wing tanks and the second diagram shows the fragmentation of the upper skin of the left wing. This diagram was produced by analysts at the China Lake Naval Weapons Center. Only hydraulic RAM forces could produce this type of damage pattern.

1. Note the comparison of right and left upper wing skin damage. The bottom skins of both wings do not show this pattern.
2. Note the right wing is far less damaged despite a harder impact with the ocean. It was attached to the heavy fuselage at impact; the left wing was not.

3. The outer third of each wing separated early in the break-up sequence from high G overload.
4. Note extensive damage to left upper wing skin was confined to areas immediately over full or nearly full wing tanks. This implies the damage was a result of hydraulic RAM forces conveyed by fuel immediately under the skin.

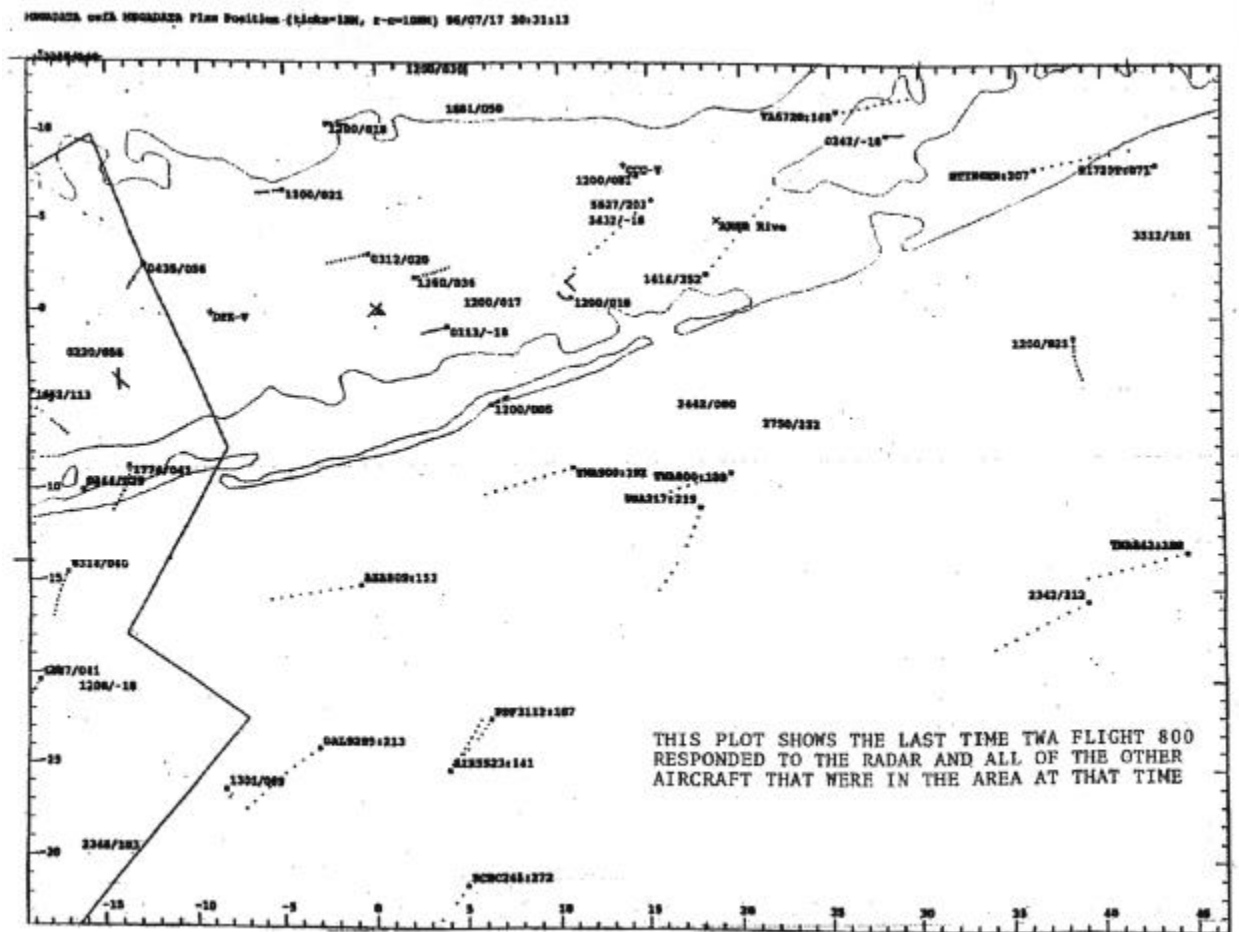
EXHIBIT 13 - MEGADATA SYSTEMS, INC. TRANSPONDER PLOT @ 20:31:13

This transponder plot shows TWA Flight 800's altitude as 13,800'. It was received at 20:31:13.

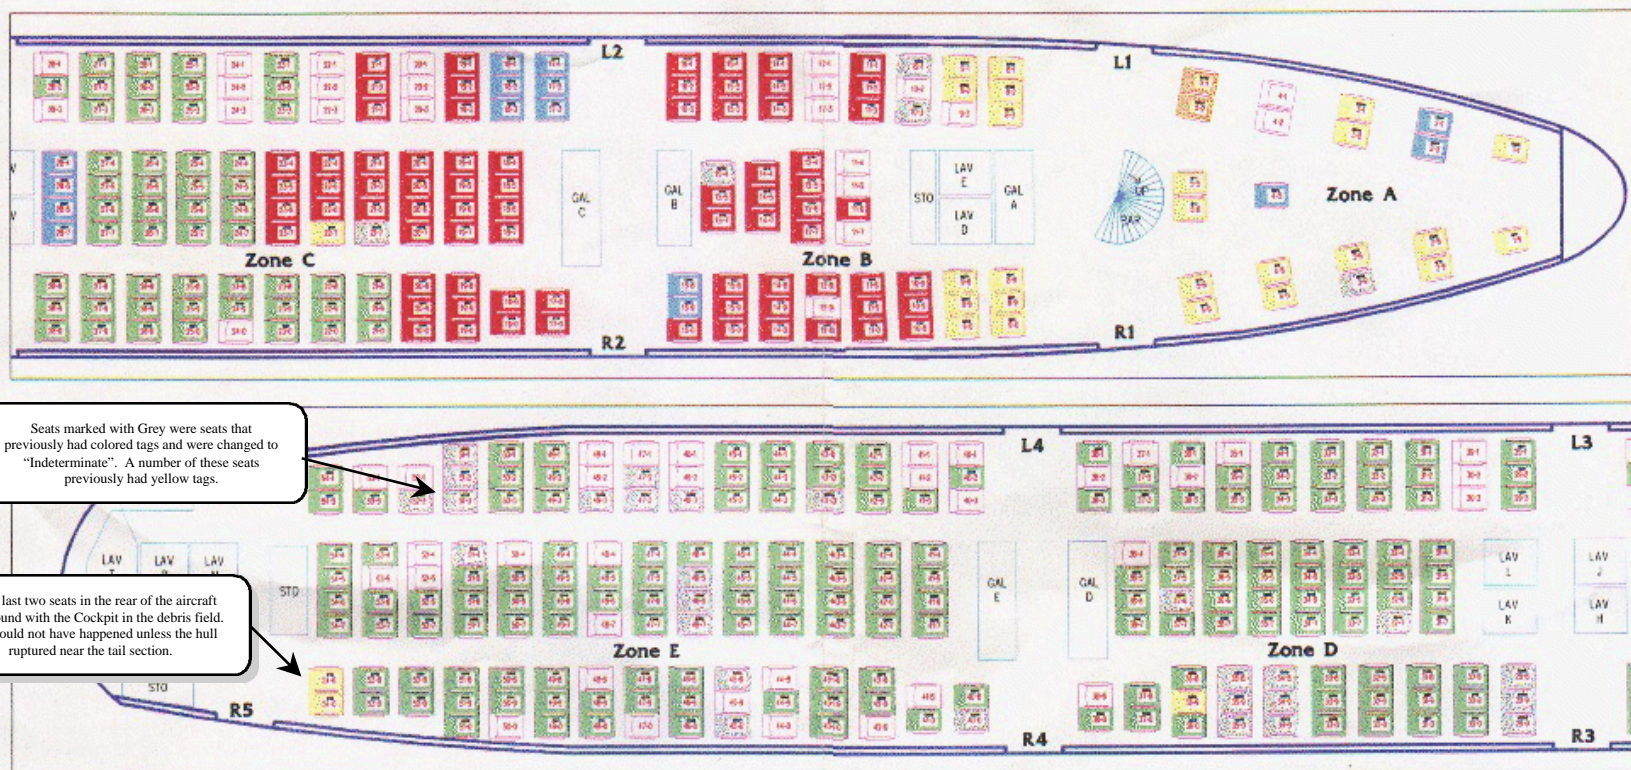
Exhibit 21 - Locations of Recovered Seats in the Debris Field

Notice the Yellow seats located in the rear of the aircraft. These seats were recovered in the early debris field with the nose section. This indicates that the aircraft hull ruptured near the Tail releasing some seats and passengers. There are a large number of White seats located in the rear section of the aircraft. This indicates their location was undetermined. NTSB officials were caught by Linda Kuntz changing seat tags because they could not explain their locations.

Seats marked with Grey were seats that previously had colored tags and were changed to "Indeterminate". A number of these seats previously had yellow tags.

These last two seats in the rear of the aircraft were found with the Cockpit in the debris field. This could not have happened unless the hull ruptured near the tail section.

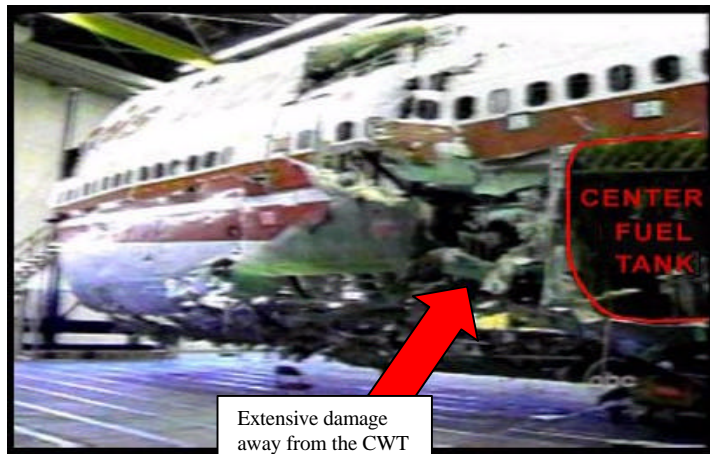
The photograph to the left shows the left side of the aircraft. Notice the high velocity damage which is low on the left side of the fuselage. The corresponds exactly with other calculations of the location of the first warhead blast. There is significant fragmentation at this location with very little skin damage in the surrounding area.

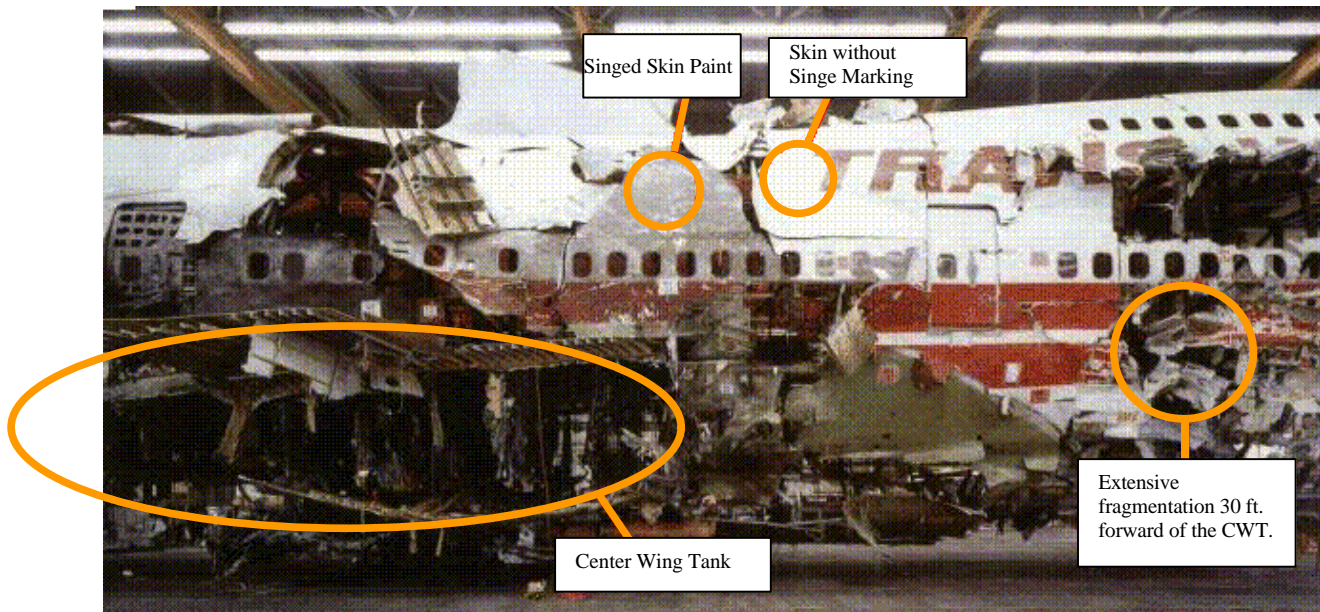
The photograph below shows the right side of the aircraft where the blast damage is

much greater and farther away from the Center Wing Tank. The metal is petaled outward as if a high velocity fragment transited the aircraft from left to right.

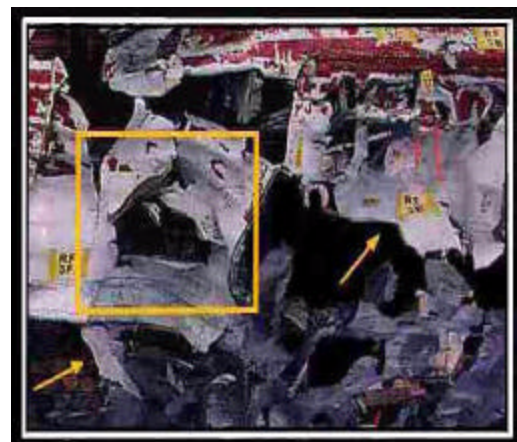
The close up at the right shows the extreme fragmentation on the right side. Notice the metal is petaled outward.

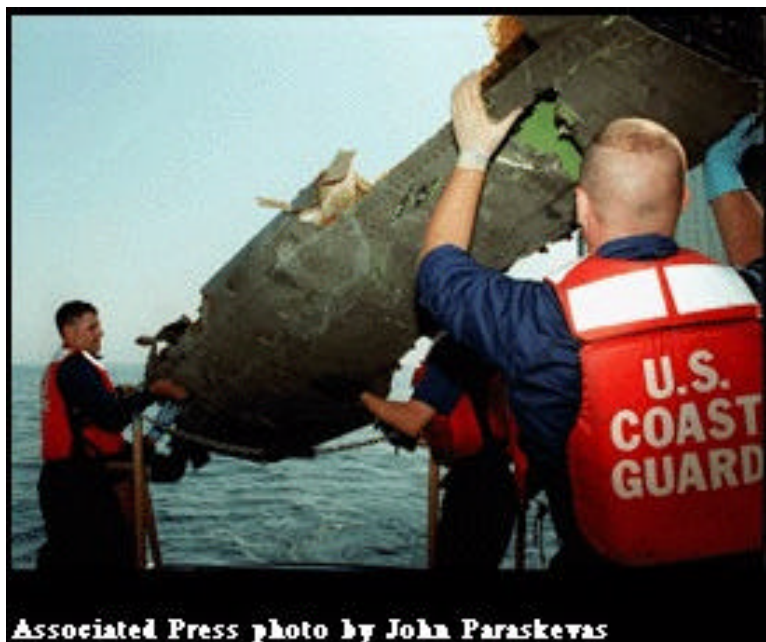
The picture at the left shows the recovery of a part, possibly a wing section, which has a number of holes which appear to have penetrated from the outside in.

The damage to this aircraft part does not appear to be consistent with a low velocity, 60-psi, explosion of the center wing tank or of impact damage from the part hitting the surface of the water. It is indicative of the type of damage that would be expected from a high velocity, anti-aircraft warhead bursting in proximity to the aircraft.

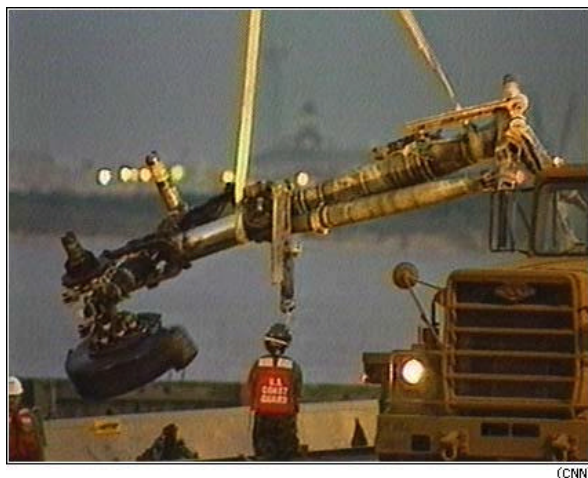
The photograph at the right appears to be a wing landing gear. We know from the debris field that the nose gear doors came off very early and landed in the earliest part of the debris field. A “part of tire” was one of the western most parts of the aircraft, as well as the nose gear doors. Notice the shredded tire in the photograph. Aircraft tires are extremely tough and often survive aircraft crashes intact. A 60 psi center wing tank explosion alone could neither blow off the nose gear doors and separate a nose tire nor do the damage to a wing gear as shown here. On the other hand, this is exactly what one would expect from a proximity-fused warhead exploding below the nose of the aircraft.

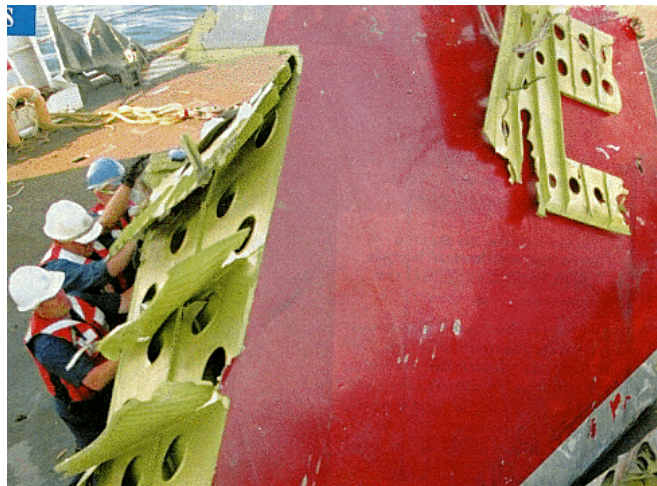
The photograph to the left is part of the tail section vertical stabilizer. Notice the clean, unsooted condition of this large section of the tail. It was located floating by eyewitnesses at least 1 mile from the fuselage impact area. See Captain Adams statement on page 19.

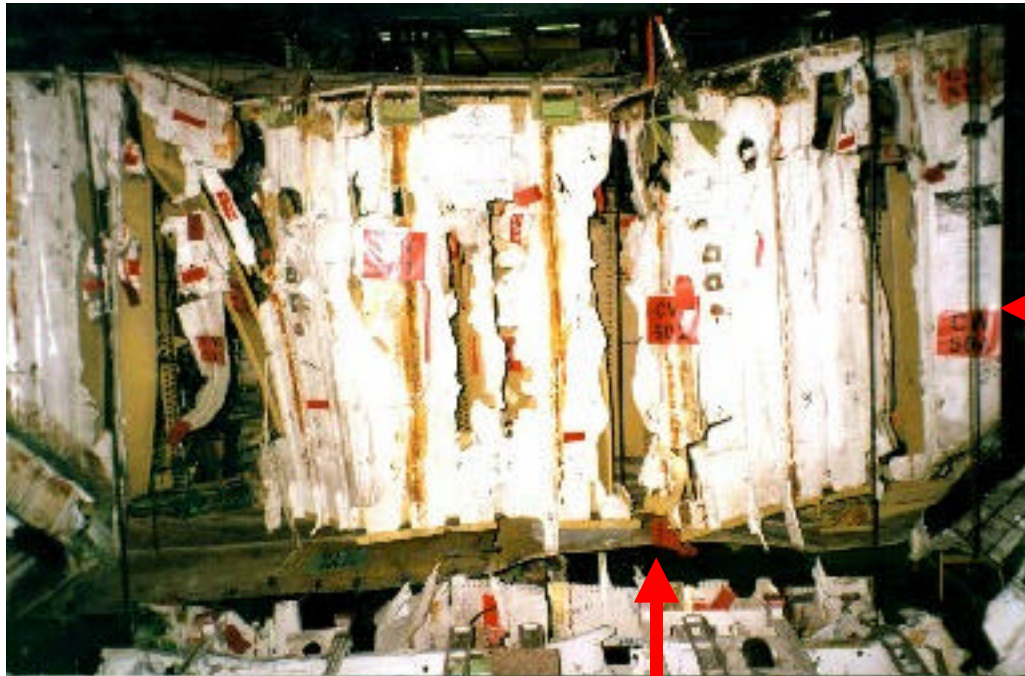
**CW 504.
First part
to leave the
aircraft.**

The picture below shows the front of the Center Wing Tank reconstruction looking back toward the tail of the aircraft from the baggage compartment. CW 504 was the part found in the debris field closest to JFK airport. Therefore, it had to have come off of the aircraft in the initial explosion.
