**Interim Report
on the
Crash of TWA Flight 800
and the
Actions of the NTSB and the FBI**

Cmdr. William S. Donaldson, USN Ret.

July 17, 1998

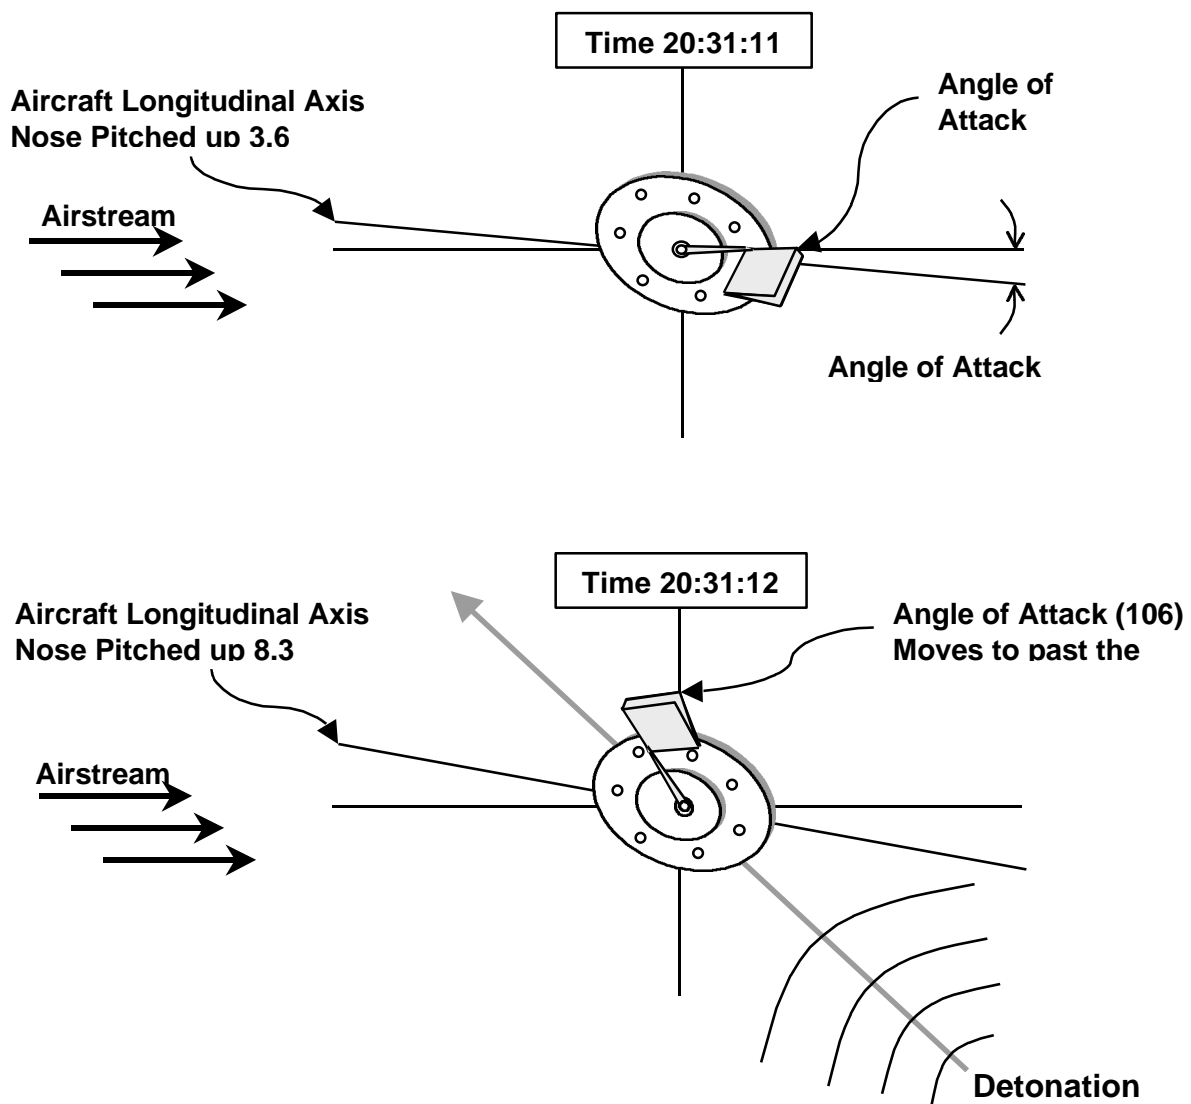
The Angle of Attack represents the angle the airstream is striking the leading edge of the wing. It is sensed by a weather vane device on the left side of the forward fuselage. It is intended to give the pilot advance warning of an imminent stall. Navy jet pilots use Angle of Attack to fly precise landings aboard aircraft carriers. When an aircraft stalls there is buffeting over the wing and a certain amount of shaking. The Stall Warning System augments this warning by shaking the control column. A small electric motor mounted on the forward side of the column incorporates an out of balance flywheel which shakes the control column before the wing actually stalls. Initiation of the warning varies with the amount of wing flaps in use. At Time 20:31:11 the flight data Recorder indicates a normal Angle of Attack of 3 degrees. At the time of the excursions we see on the 20:31:12 second line the FDR indicates an Angle of Attack of 106 degrees, followed by 30 degrees. The 30 degrees is the final Angle of Attack reading from TWA FL800. There is, however, one more Angle of Attack reading on the FDR. That reading of 3 degrees did not come from FL800 but rather from TWA FL803 data that was recorded 25 hours earlier and not yet erased.

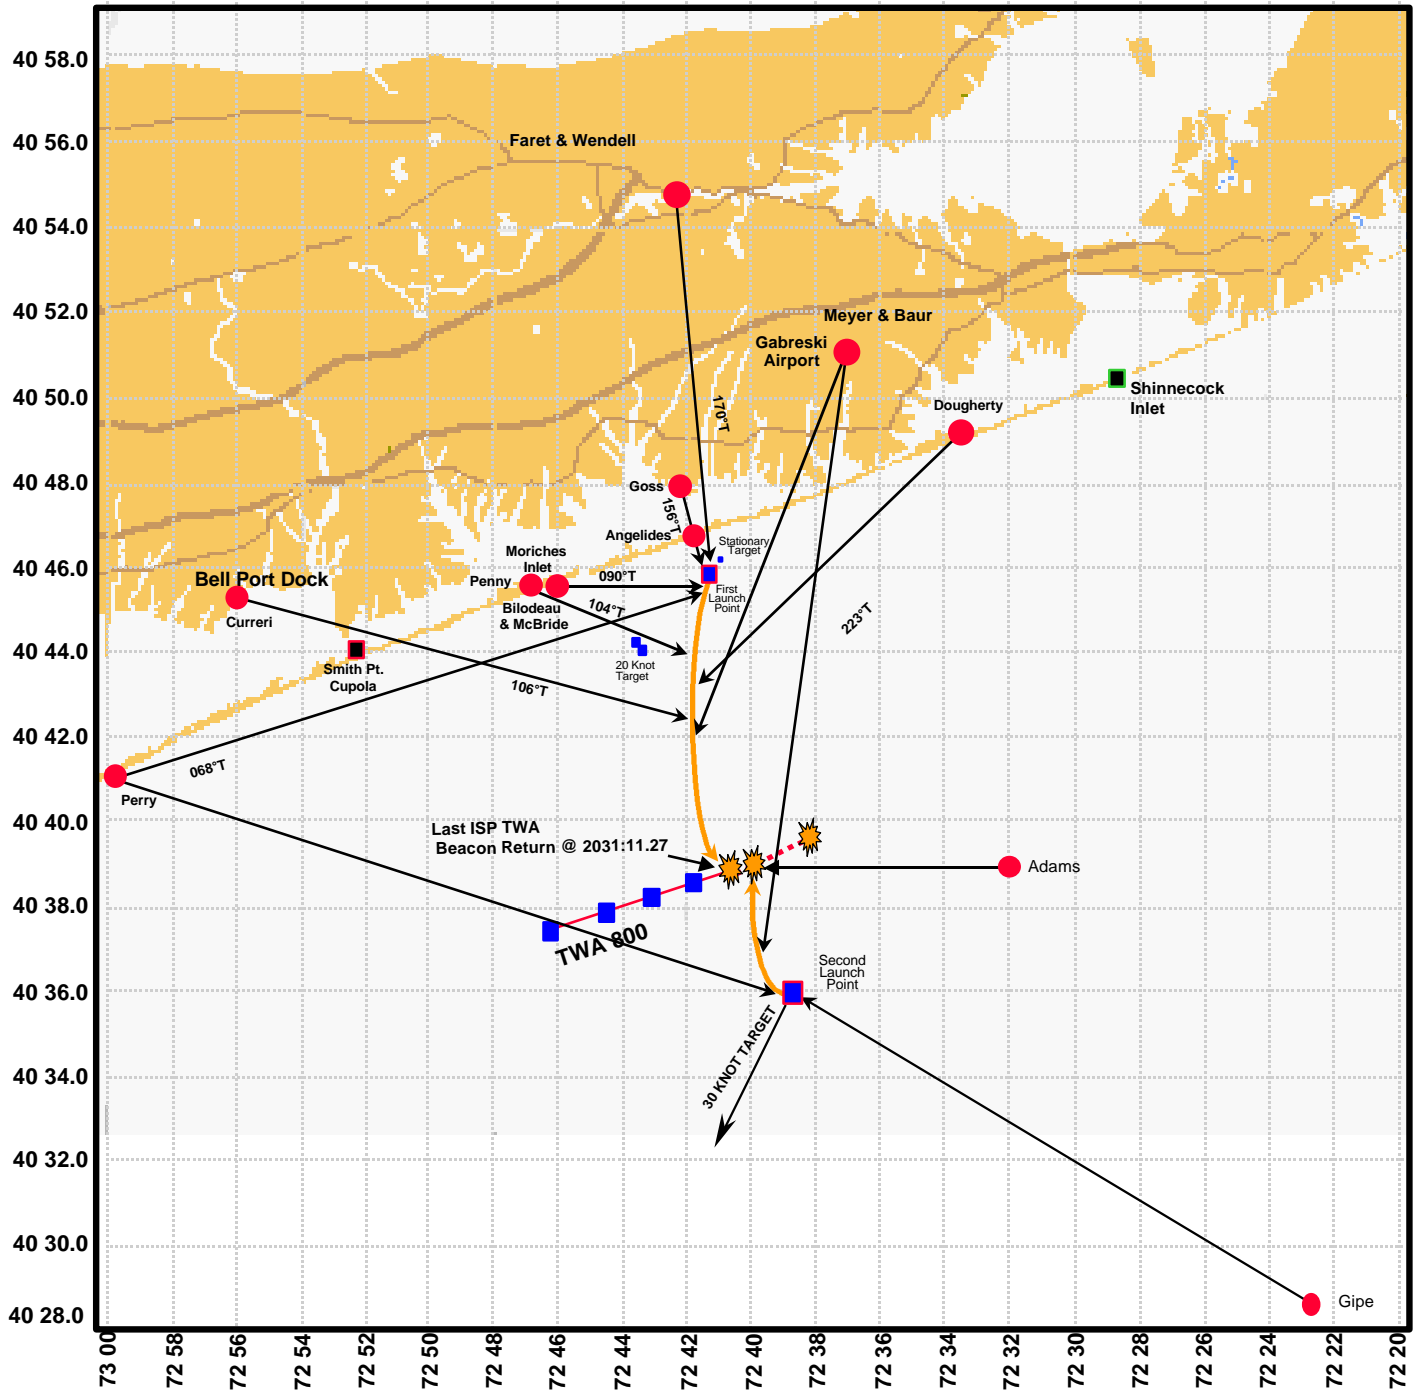
Exhibit 16 - Triangulation of Witness Bearing Lines

The triangulation of witness observations was accomplished by thoroughly interviewing witnesses, and in many cases, going to the spot where the witness was located when they spotted the streak in the sky. A GPS position fix was used to document the location and the witness was asked to point to the spot where they first saw the streak. In many cases, there were reference objects, such as a house, pier or other fixed object which the witness could point to as a reference. A hand-bearing compass was then used to get the magnetic bearing. The witness was asked to describe the sequence of events, sights, sounds, vibrations, etc. In all but one case listed here, the witness first saw the object, then heard sounds sometime later. A number of witnesses took careful extemporaneous notes of their observations. These observations were then converted from Magnetic to True bearings and plotted on the above chart. The NTSB radar track of the last secondary return was then also plotted on the chart. Each of these witnesses saw the streak of light for a number of seconds, then saw one or more white explosions, followed some seconds later by a large orange fireball.

As you can see from the plot, the witnesses saw the streak from quite a few different angles and at different points in its flight. This explains the variability in witness statements as to direction of their observation and direction of travel with respect to them. Since none of them first heard the sounds, their observations cannot be explained away by the CIA video which was produced to suggest that all the eyewitnesses saw the crippled, headless aircraft climbing 3,000 ft. trailing burning fuel.

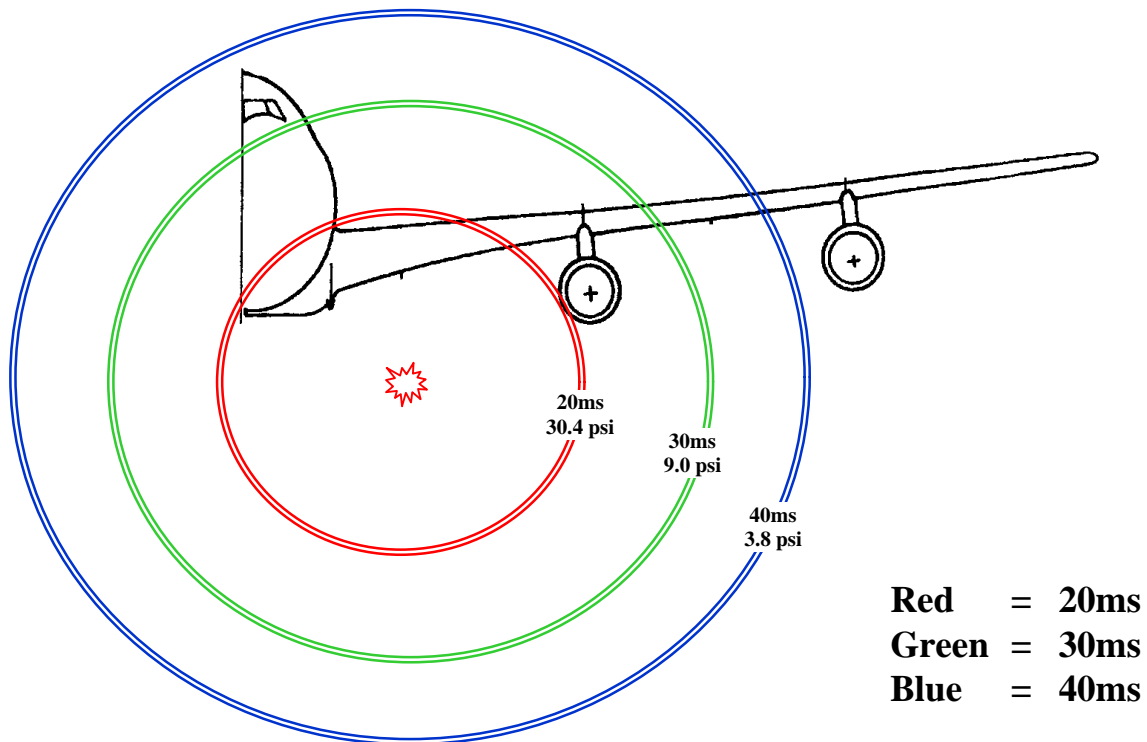
Overpressure vs. Burst Radius

90 lb. High Explosive Warhead Airburst
